**Flood Control Project Maintenance  
Levee Inspections**  
**LMA District Cover Sheet**  
**Spring 2019 Levee Inspection Results**

**Levee District No. 0003 (Glenn County)**

**Spring 2019 Levee Inspection Results**

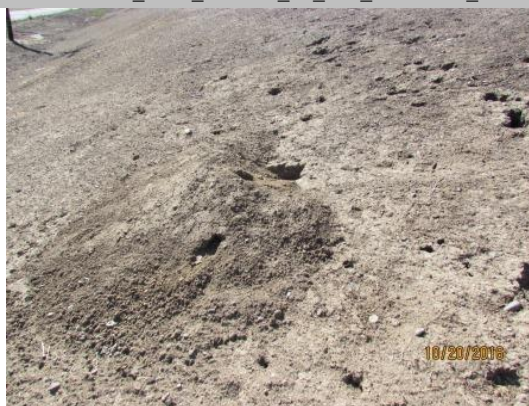
Photo 1 of 1 : SP\_2019\_LD0003\_27\_104\_20190319\_00056.jpg

LM Start	1.75	Rating **	U	Issue No.	104
LM End	1.98	Issue Type +	Ma	Location *	LS
Category	Earthen Levee			GPS Latitude/Longitude	
				Start	End
Item	Animal Control			39.401795 °	39.405018 °
				-122.002084 °	-122.001672 °
DWR ID	DWR_LD0003_01_f_2016_104				
Comment Code					
A1 : Exterminate rodents and backfill and compact or grout burrows.					
Inspector Comment

View of the rodent holes along the landside slope.

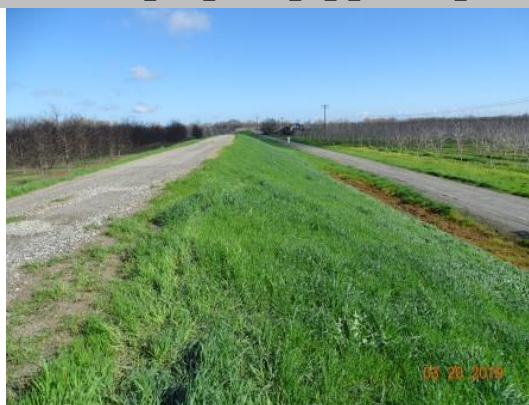
Photo 1 of 1 : SP\_2019\_LD0003\_27\_8\_20190322\_00100.jpg

LM Start	1.78	Rating **	M	Issue No.	8
LM End	2.14	Issue Type +	Ma	Location *	LS
Category	Earthen Levee			GPS Latitude/Longitude	
				Start	End
Item	Vegetation			39.402225 °	39.406402 °
				-122.002053 °	-121.999907 °
DWR ID	DWR_LD0003_01_s_2019_8				
Comment Code					
V1 : Control annual grass and weeds on the levee slopes and easements.					
Inspector Comment

View of the vegetation on the landside slope, facing upstream.

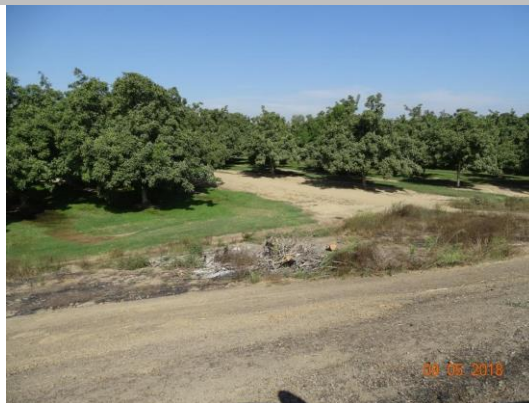
Photo 1 of 1 : SP\_2019\_LD0003\_27\_69\_20190319\_00036.jpg

LM Start	4.11	Rating **	M	Issue No.	69
LM End	4.11	Issue Type +	En	Location *	WS
Category	Earthen Levee			GPS Latitude/Longitude	
				Start	End
Item	Encroachments			39.427917 °	39.427917 °
				-121.987947 °	-121.987947 °
DWR ID	DWR_LD0003_01_f_2018_69				
Comment Code					
PR : Prunings					
Inspector Comment					
Remove the prunings from the waterside toe.

View of the prunings along the waterside toe.

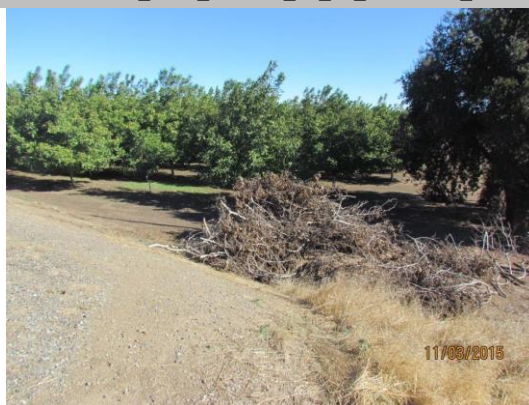
Photo 1 of 1 : SP\_2019\_LD0003\_27\_66\_20190319\_00033.jpg

LM Start	4.33	Rating **	M	Issue No.	66
LM End	4.33	Issue Type +	En	Location *	LS
Category	Earthen Levee			GPS Latitude/Longitude	
				Start	End
Item	Encroachments			39.430927 °	39.430927 °
				-121.987142 °	-121.987142 °
DWR ID	DWR_LD0003_01_f_2015_66				
Comment Code					
PR : Prunings					
Inspector Comment					
Remove the prunings from the landside slope.

View of the prunings along the landside toe.

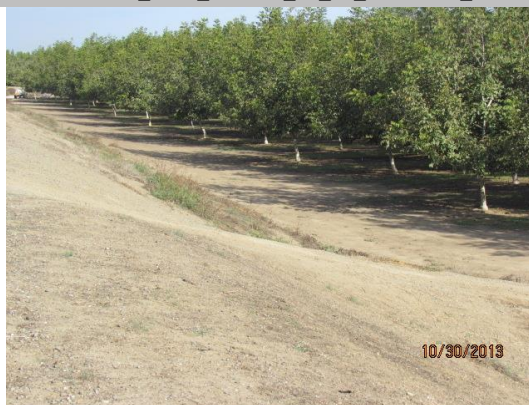
Photo 1 of 1 : SP\_2019\_LD0003\_27\_64\_20190319\_00031.jpg

LM Start	4.63	Rating **	U	Issue No.	64
LM End	4.68	Issue Type +	Ma	Location *	LS
Category	Earthen Levee			GPS Latitude/Longitude	
				Start	End
Item	Animal Control			39.435205 °	39.435855 °
				-121.988097 °	-121.988252 °
DWR ID	DWR_LD0003_01_f_2013_64				
Comment Code					
A3 : No rodents visible, but rodent burrows visible; need to backfill and compact or grout burrows.					
Inspector Comment

View of the rodent activity along the landside slope.

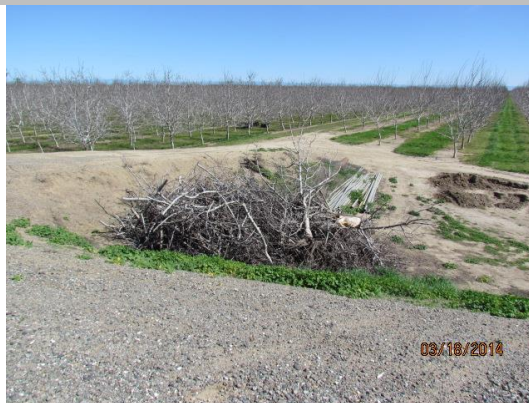
Photo 1 of 1 : SP\_2019\_LD0003\_27\_68\_20190319\_00035.jpg

LM Start	4.82	Rating **	M	Issue No.	68
LM End	4.82	Issue Type +	En	Location *	LS
Category	Earthen Levee			GPS Latitude/Longitude	
				Start	End
Item	Encroachments			39.437857 °	39.437857 °
				-121.988754 °	-121.988754 °
DWR ID	DWR_LD0003_01_s_2014_68				
Comment Code					
PR : Prunings					
Inspector Comment

View of the prunings along the landside toe.

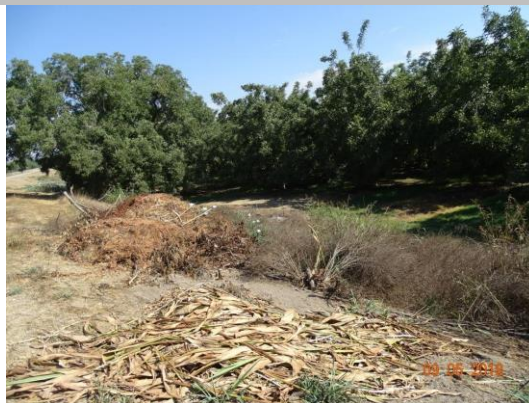
Photo 1 of 1 : SP\_2019\_LD0003\_27\_75\_20190319\_00041.jpg

LM Start	5.07	Rating **	U	Issue No.	75
LM End	5.07	Issue Type +	En	Location *	LS
Category	Earthen Levee			GPS Latitude/Longitude	
				Start	End
Item	Encroachments			39.441387 °	39.441387 °
				-121.990252 °	-121.990252 °
DWR ID	DWR_LD0003_01_f_2018_75				
Comment Code					
PR : Prunings					
Inspector Comment					
Fruit and yard waste creating rodent problem on levee.

View of the yard waste along the landside slope.

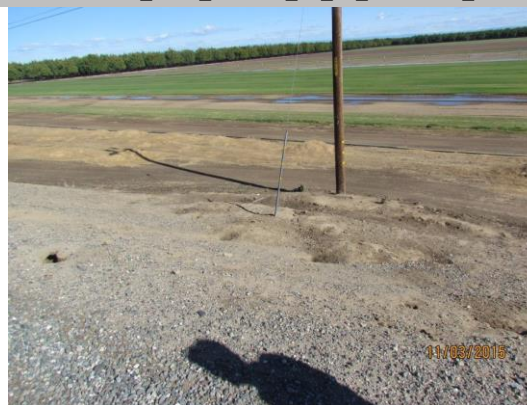
Photo 1 of 1 : SP\_2019\_LD0003\_27\_71\_20190319\_00038.jpg

LM Start	6.06	Rating **	M	Issue No.	71
LM End	6.06	Issue Type +	Ma	Location *	LS
Category	Earthen Levee			GPS Latitude/Longitude	
				Start	End
Item	Animal Control			39.455313 °	39.455313 °
				-121.993712 °	-121.993712 °
DWR ID	DWR_LD0003_01_f_2015_71				
Comment Code					
A3 : No rodents visible, but rodent burrows visible; need to backfill and compact or grout burrows.					
Inspector Comment

View of the rodent holes along the landside slope.

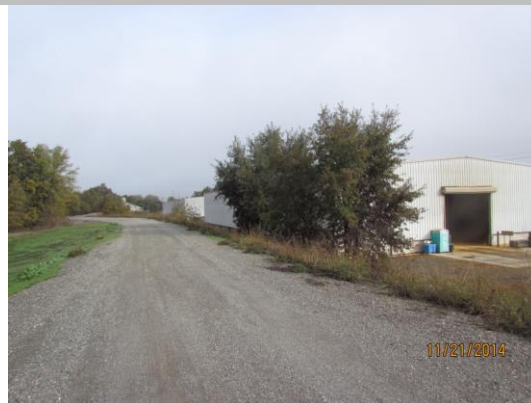
Photo 1 of 1 : SP\_2019\_LD0003\_27\_7\_20190319\_00005.jpg

LM Start	6.24	Rating **	M	Issue No.	7
LM End	6.38	Issue Type +	Ma	Location *	LS
Category	Earthen Levee			GPS Latitude/Longitude	
				Start	End
Item	Trim / Thin Trees			39.457968 °	39.459955 °
				-121.993712 °	-121.993512 °
DWR ID	DWR_LD0003_01_s _ 2012_7				
Comment Code					
T1 : Trim trees to at least five feet above ground level.					
Inspector Comment

Trim the trees 5 feet for better visibility.

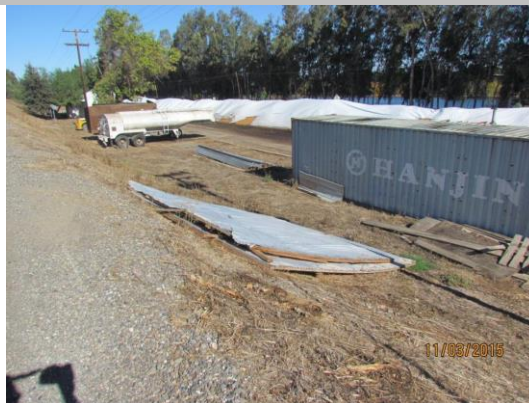
Photo 1 of 1 : SP\_2019\_LD0003\_27\_74\_20190319\_00040.jpg

LM Start	6.41	Rating **	U	Issue No.	74
LM End	6.41	Issue Type +	En	Location *	LS
Category	Earthen Levee			GPS Latitude/Longitude	
				Start	End
Item	Encroachments			39.460363 °	39.460363 °
				-121.993264 °	-121.993264 °
DWR ID	DWR_LD0003_01_f_2015_74				
Comment Code					
DE : Debris					
Inspector Comment					
Remove the metal roof from the landside slope.

View of the metal roof laying on the landside slope.

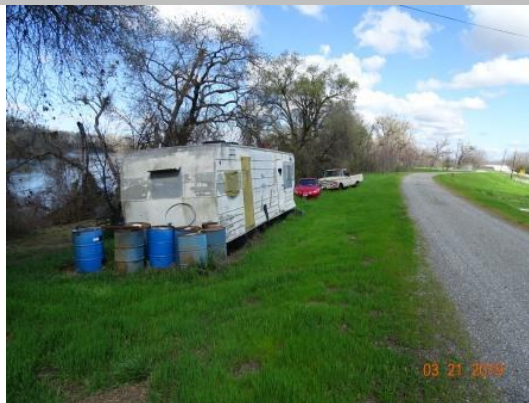
Photo 2 of 2 : SP\_2019\_LD0003\_27\_115\_20190322\_00104.jpg

LM Start	6.57	Rating **	U	Issue No.	115 (cont)	
LM End	6.61	Issue Type +	En	Location *	WS	
Category	Earthen Levee			GPS Latitude/Longitude		
				Start		End
Item	Encroachments			39.462864 °		39.463182 °
				-121.992703 °		-121.992655 °
DWR ID	DWR_LD0003_01_s_2019_115					
Comment Code						
AV : Abandoned vehicles						
Inspector Comment						
Abandoned vehicles, boats and RV on WS slope need removal.

Photo 2. View of an abandoned RV, cars and drums on the waterside slope, facing upstream.

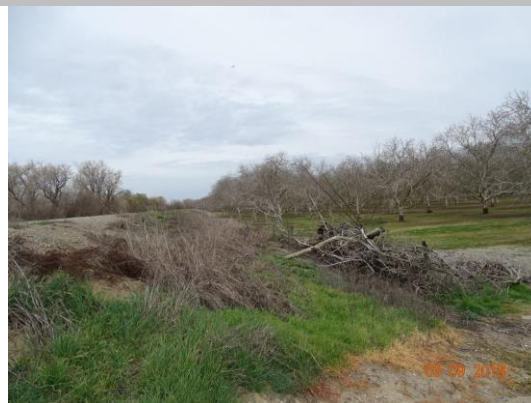
Photo 1 of 1 : SP\_2019\_LD0003\_27\_67\_20190319\_00034.jpg

LM Start	7.21	Rating **	M	Issue No.	67
LM End	7.21	Issue Type +	En	Location *	LS
Category	Earthen Levee			GPS Latitude/Longitude	
				Start	End
Item	Encroachments			39.471695 °	39.471695 °
				-121.991038 °	-121.991038 °
DWR ID	DWR_LD0003_01_s_2018_67				
Comment Code					
PR : Prunings					
Inspector Comment					
Remove the prunings from the landside slope.

View of the prunings on the landside slope.

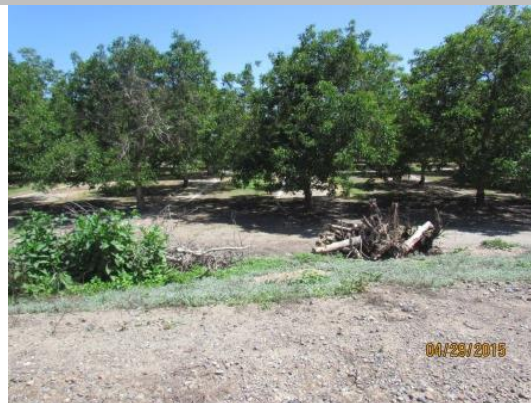
Photo 1 of 1 : SP\_2019\_LD0003\_27\_37\_20190319\_00017.jpg

LM Start	7.36	Rating **	M	Issue No.	37
LM End	7.36	Issue Type +	En	Location *	LS
Category	Earthen Levee			GPS Latitude/Longitude	
				Start	End
Item	Encroachments			39.473793 °	39.473793 °
				-121.991208 °	-121.991208 °
DWR ID	DWR_LD0003_01_s_2012_37				
Comment Code					
PR : Prunings					
Inspector Comment					
Remove the prunings from the landside slope.

View of the prunings along the landside slope.

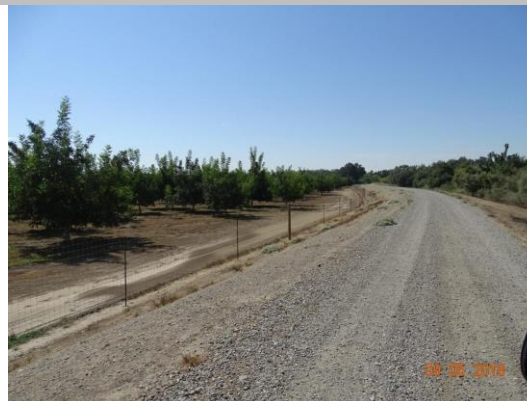
Photo 1 of 1 : SP\_2019\_LD0003\_27\_85\_20190319\_00048.jpg

LM Start	8.79	Rating **	M	Issue No.	85
LM End	9.09	Issue Type +	En	Location *	LS
Category	Earthen Levee			GPS Latitude/Longitude	
				Start	End
Item	Encroachments			39.493498 °	39.497052 °
				-121.990820 °	-121.987823 °
DWR ID	DWR_LD0003_01_f_2018_85				
Comment Code					
FE : Fence					
Inspector Comment					
Temporary fence from landside toe should be removed

View of the fence along the landside toe.

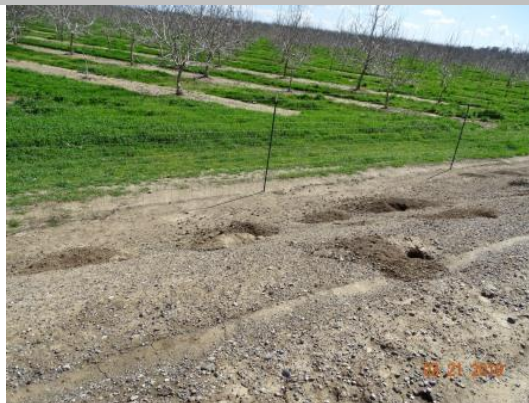
Photo 1 of 1 : SP\_2019\_LD0003\_27\_124\_20190322\_00110.jpg

LM Start	9.03	Rating **	U	Issue No.	124
LM End	9.03	Issue Type +	Ma	Location *	LS
Category	Earthen Levee			GPS Latitude/Longitude	
				Start	End
Item	Animal Control			39.496442 °	39.496442 °
				-121.988539 °	-121.988539 °
DWR ID	DWR_LD0003_01_s_2019_124				
Comment Code					
A1 : Exterminate rodents and backfill and compact or grout burrows.					
Inspector Comment

View of multiple large rodent holes on the landside slope, facing downstream. (Spring 2019)

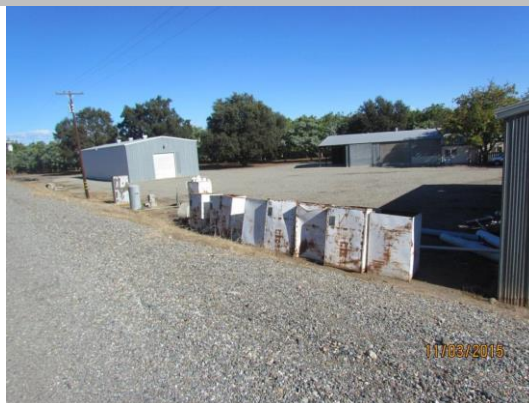
Photo 1 of 1 : SP\_2019\_LD0003\_27\_77\_20190319\_00043.jpg

LM Start	9.12	Rating **	M	Issue No.	77
LM End	9.12	Issue Type +	En	Location *	LS
Category	Earthen Levee			GPS Latitude/Longitude	
				Start	End
Item	Encroachments			39.497452 °	39.497452 °
				-121.987673 °	-121.987673 °
DWR ID	DWR_LD0003_01_f_2015_77				
Comment Code					
EQ : Equipment					
Inspector Comment					
Remove the metal boxes from the landside toe.

View of the metal boxes along the landside toe.

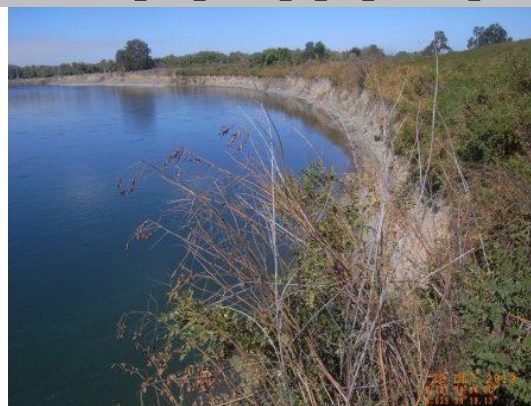
Photo 1 of 3 : SP\_2019\_LD0003\_27\_106\_20190319\_00058.jpg

Comment Code					
Inspector Comment					
2017 Site ID: SAC 172.0 L					
Status: Critical					
2017 Field Notes: Significant erosion in last year. Erosion is entering levee prism, at current erosion rate, one more large storm and the levee will be comprised. Upgraded to critical.					
Site History: 2007 - Getting close to the levee. Bank is clayey silt with clayey/silty toe. 2008 - Looks a little worse at the upstream end. 2009 - Some new erosion and slumping. 2010 - Some new erosion upstream of site, actively eroding at low flow. New bank swallow colony noted. 2011 - Significant erosion since last year, with an estimated 10 to 15 feet of berm lost. Large sections of the bank have slumped off. 2012 - Part of the site appears to be stabilizing, but still minor slumping in other locations. 2013 - Minor new erosion at toe.

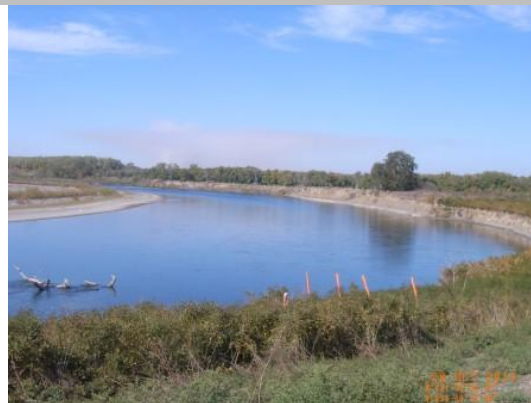
Photo 2 of 3 : SP\_2019\_LD0003\_27\_106\_20190319\_00059.jpg

Comment Code					
Inspector Comment					
2017 Site ID: SAC 172.0 L					
Status: Critical					
2017 Field Notes: Significant erosion in last year. Erosion is entering levee prism, at current erosion rate, one more large storm and the levee will be comprised. Upgraded to critical.					
Site History: 2007 - Getting close to the levee. Bank is clayey silt with clayey/silty toe. 2008 - Looks a little worse at the upstream end. 2009 - Some new erosion and slumping. 2010 - Some new erosion upstream of site, actively eroding at low flow. New bank swallow colony noted. 2011 - Significant erosion since last year, with an estimated 10 to 15 feet of berm lost. Large sections of the bank have slumped off. 2012 - Part of the site appears to be stabilizing, but still minor slumping in other locations. 2013 - Minor new erosion at toe.

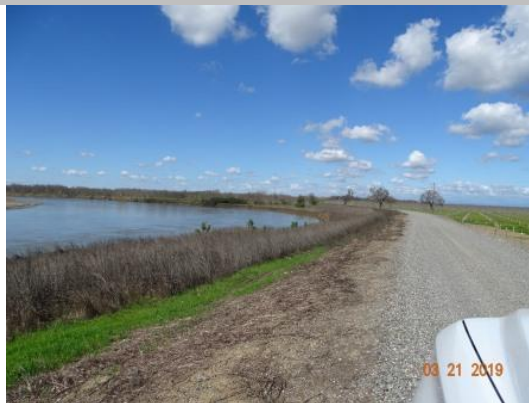
Photo 1 of 1 : SP\_2019\_LD0003\_27\_126\_20190322\_00112.jpg

LM Start	9.64	Rating **	U	Issue No.	126
LM End	9.84	Issue Type +	Ma	Location *	WS
Category	Earthen Levee			GPS Latitude/Longitude	
				Start	End
Item	Vegetation			39.504584 °	39.507405 °
				-121.984522 °	-121.984049 °
DWR ID	DWR_LD0003_01_s_2019_126				
Comment Code					
V2 : Remove the wild growth other than native grasses from the levee slopes.					
Inspector Comment

View of the wild growth along the waterside slope, facing upstream.  
(Spring 2019)
